City of Vancouver

WATER RESOURCES PROTECTION - CATCH BASIN FILTER PROGRAM

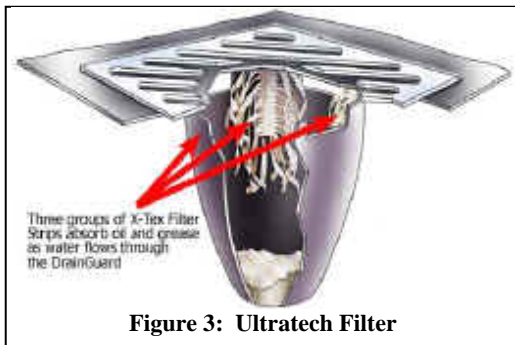
Figure 3: Ultratech Filter

The City chose Ultratech brand sock filters to install in catch basins. Published performance data indicates that these filters are capable of removing sediments down to the 80 µm range and over 90% of oils. The filters had a reported oil capacity of 1.38 gallons of oil and a sediment capacity of up to 40 lbs¹. Note that although a filter may structurally hold 40 lbs, sediment levels begin to approach the overflow ports at 20-25 lbs.

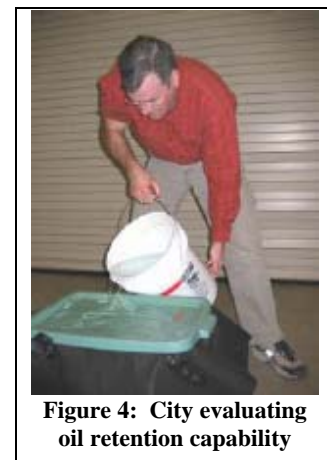
Figure 4: City evaluating oil retention capability

Oil capture performance was evaluated by WRP staff using a synthesized oil-water solution and comparative testing. The City’s lab data and calculations verified that a filter could capture over 90% of the oil and retain over a gallon of oil in the filter fabric. These results are presented in Tables 1 and 2.

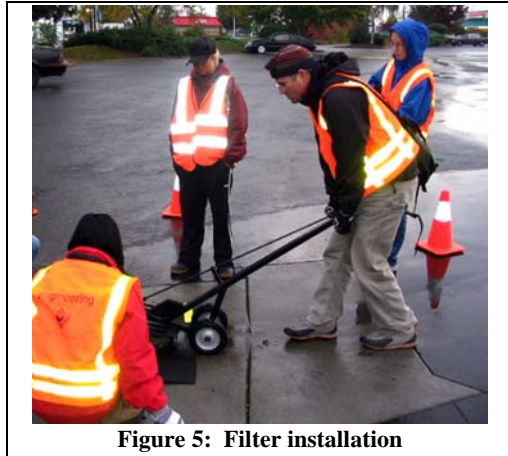
Figure 5: Filter installation

Typically one volunteer evaluated the catchment area for sources of sediment, oil contamination or trash, while three others installed the filter. After placement, the excess filter material was trimmed. Filters were installed in 4 hour shifts, with installation time for each filter averaging about 15 minutes. The catchment area of each catch basin was determined through field measurements and with the help of a Water Resources Protection GIS application.

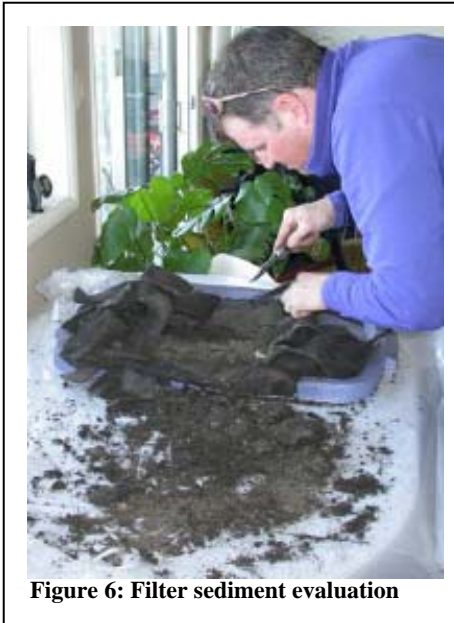
Figure 6: Filter sediment evaluation

The filters were transported to a covered area and hung to dry. After about 3 weeks of drying, they were examined and re-weighed.

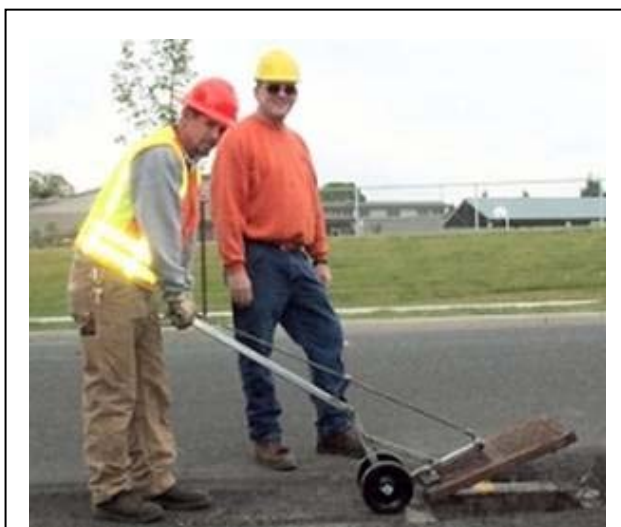
Figure 8: City Operations designed grate lifter

A staff member in the City's Surface Water Operations group designed and built a useful grate lifting tool which allows one person to easily lift catch basin grates (Fig. 8).
